Effects of Suffusion in Dam Core Soils with Varying Degrees of Internal Instability

Hans Rönnqvist¹, Peter Viklander²

This study investigates the effects of varying degrees of internal instability of glacial till on the grading characteristics due to internal erosion. Glacial till is used as impervious core material in dams in many parts of the world. Internal erosion can be initiated by backward erosion, suffusion, contact erosion and concentrated leak erosion. The initiation mechanism of suffusion is based on the internal instability of gradation, while backward erosion occurs due to an unfiltered interface. Based on a laboratory experimental program conducted on 12 non-plastic glacial till specimens, four of which were glacial till core soils obtained from four existing embankment dams in Sweden, and eight of which were mixtures containing gravel and the aforementioned tills, the effect of the stability index $(H/F)_{\min}$ on soil samples subjected to a downward gradient was determined. Six specimens were considered stable, four failed by suffusion and two failed by backward erosion. The effect on erosion mass loss, pre- and post-test gradations and grading characteristics ar

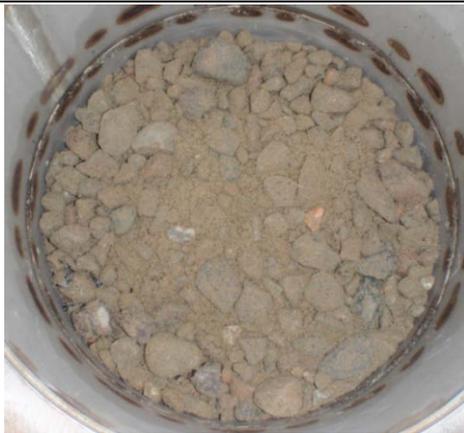
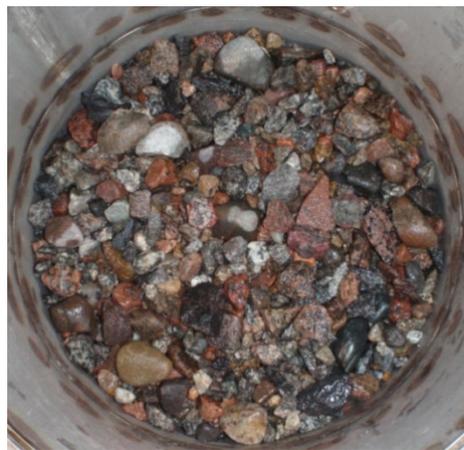
Figure 3: Forensic photo of the top layer 4 of unstable specimen ST3: (A) pre-test surface compacted to a relative density of 90%; (B) post-test; completely suffused specimen.

Four of the 12 specimens underwent suffusion due to internal instability (BE3, BE4, GR3, and ST3), two failed by backward erosion (GBE) (GR2 and ST2), and the remaining six specimens performed without signs of instability (BE1, BE2, RA1, GR1, GR4, and ST1) (Table 2). Fig. 3 shows forensic photos of specimen ST3, which completely suffused revealing the primary fabric, whereas the incompletely suffused BE4 is shown in Fig. 4. The diagnostic criterion was analysis of pre- and post-test gradation curves, supplemented by head loss profiles and mass loss data; a change in post-test gradations, irregular head loss profiles and excessive mass loss would thus indicate instability (Rönnqvist et al, 2017).

For incompletely suffused specimens (Fig. 4), the stability index decreased (i.e., BE3, BE4 and GR3), whereas for the completely suffused specimen ST3 (Fig. 3), the expected increase in the post-test stability index is observed due to the complete wash-out of the unstable finer fraction (Fig. 7). The pre-test stability index for ST3 was $(H/F)_{\min} = 0.15$, and the corresponding excessive erosion boundary was exceeded by the filter (Fig. 5). Thus, for ST3, an open type system that allowed for the complete erosion of the specimen was present. On the contrary, specimens BE3, BE4 and GR3 did not fully suffuse, despite being internally unstable with an $(H/F)_{\min}$ of 0.55, 0.33 and 0.28, respectively (Fig. 2, Fig. 7). Incomplete suffusion may be due to one or more of the following:

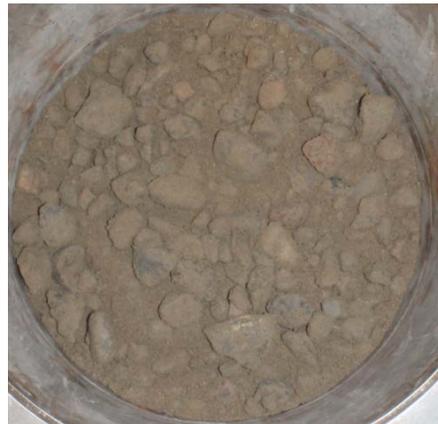
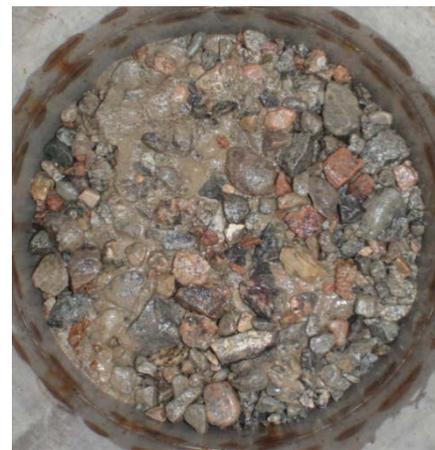
Figure 4: Forensic photo of top layer 4 of unstable specimen BE4: (a) pre-test surface compacted to a relative density of 95%; and (b) post-test; incompletely suffused top layer.
